**Service Bulletin
1-29-15**

Auxiliary Airbox Retention

Engine installations typically installed in Van's aircraft. These are only up draft sump installations with FM-100 or FM-200, FM-200A fuel controls, using Vans filtered air box

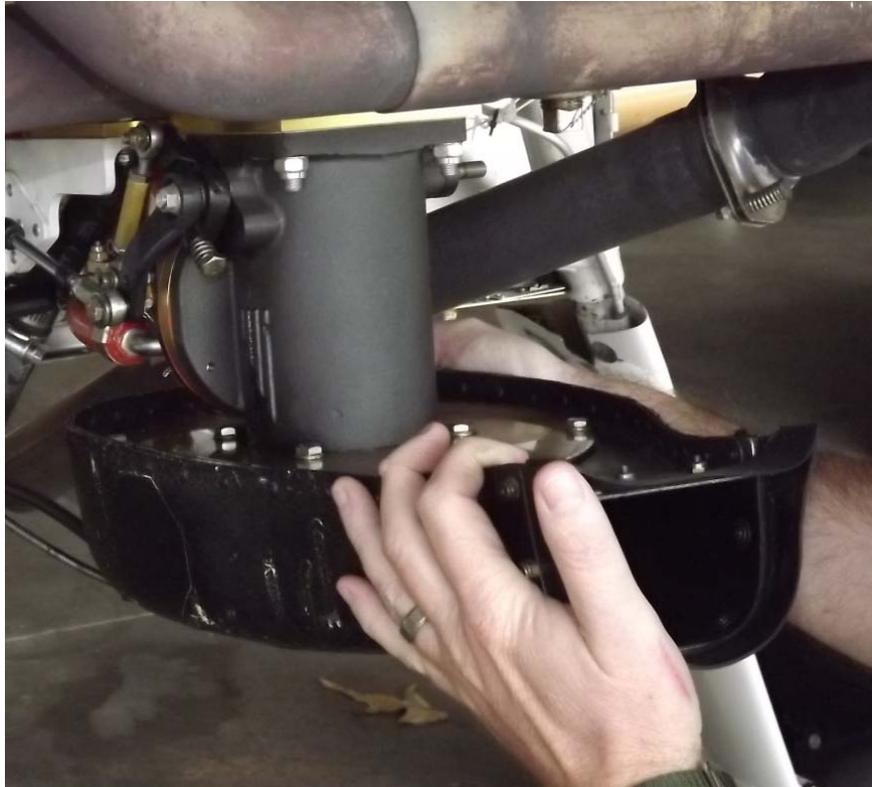
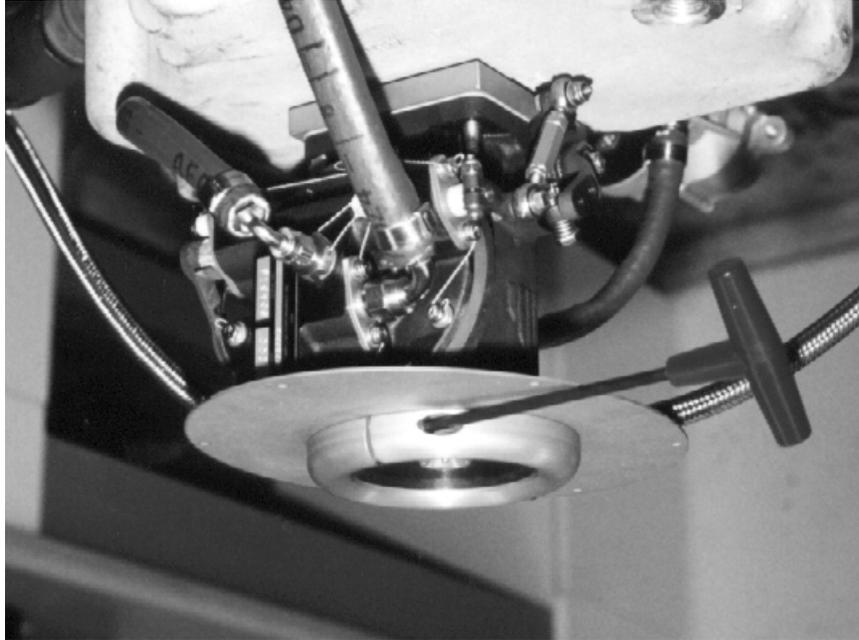
Check the security of the air box assembly by trying to rotate the box relative to the throttle body. Inspect the air box mount plate for cracking around the 4 hex bolt mounting holes. If the air box is secure and the air box mount plate is OK then proceed with step 2.

1.) If the assembly moves, mark the correct position of the box mount plate relative to the throttle body so that the air box correctly lines up with the opening on the cowl. Remove the fiberglass portion of the air box to expose the approach clamp ring. Loosen the 4 hex bolts holding the air box mount plate to the approach clamp ring. Inspect the throttle body for damage. If the contact portion of the throttle body is damaged where the approach clamp ring attaches, Contact Airflow Performance for further instructions. Apply thread locker (Locktite 243 or equivalent) to pinch bolt cap screw and torque the ¼-20 socket head cap screw pinch bolt to 75-80 in-lbs. Before re-installing the fiberglass air box clean and inspect this venture in the throttle body. The boost venture can be cleaned with a Q-tip wetted with Brake Kleen or lacquer thinner. Clean the main venture with a rag wetted with Brake Kleen or lacquer thinner. Do not use any sharp objects to clean these components. Inspect the air filter and clean if necessary. Re-install the fiberglass air box.
